RECONSTRUCTION OF
NORTH VIETNAMESE
THERMAL-ELECTRIC
POWERPLANTS

NPIC/R-82/69

SEPTEMBER 1969

NATIONAL PHOTOGRAPHIC INTERPRETATION CENTER

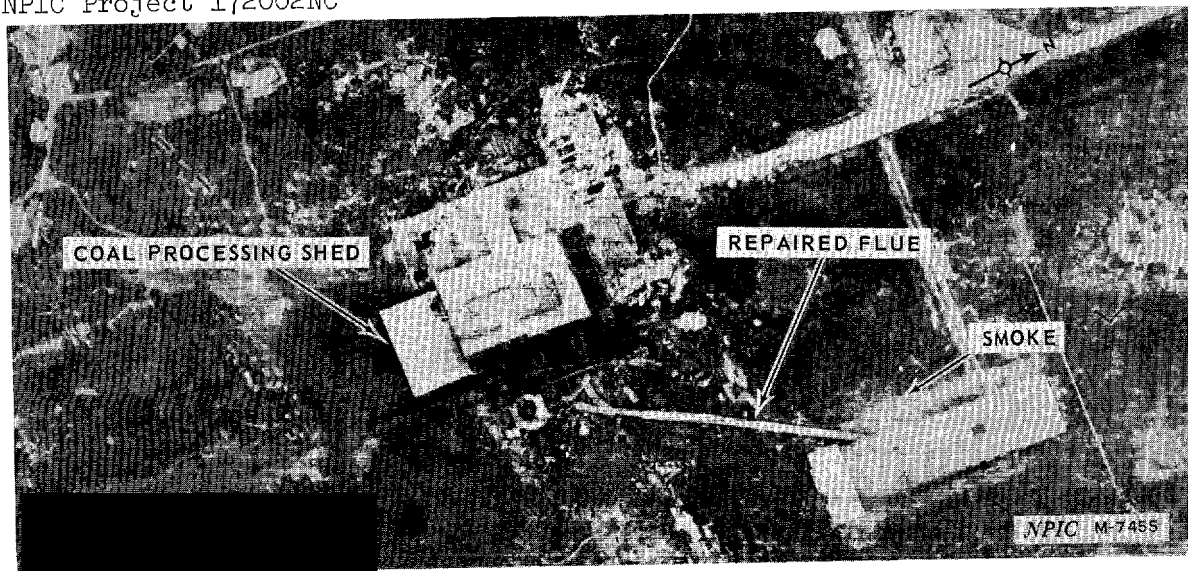
FIGURE 2. THERMAL-ELECTRIC POWERPLANT, BEN THUY, NORTH VIETNAM

The Ben Thuy TPP, heavily damaged in mid-1965, was subsequently restored, and was damaged again in early 1968. The latest reconstruction of the plant has continued since initial repairs to the disposal system were observed [REDACTED]. Boiler testing may have occurred as early as [REDACTED] but was not confirmed until [REDACTED]. The repair of all essential plant components has now been completed and the observation of smoke rising from the flue system indicates that it is operational (Figure 2).

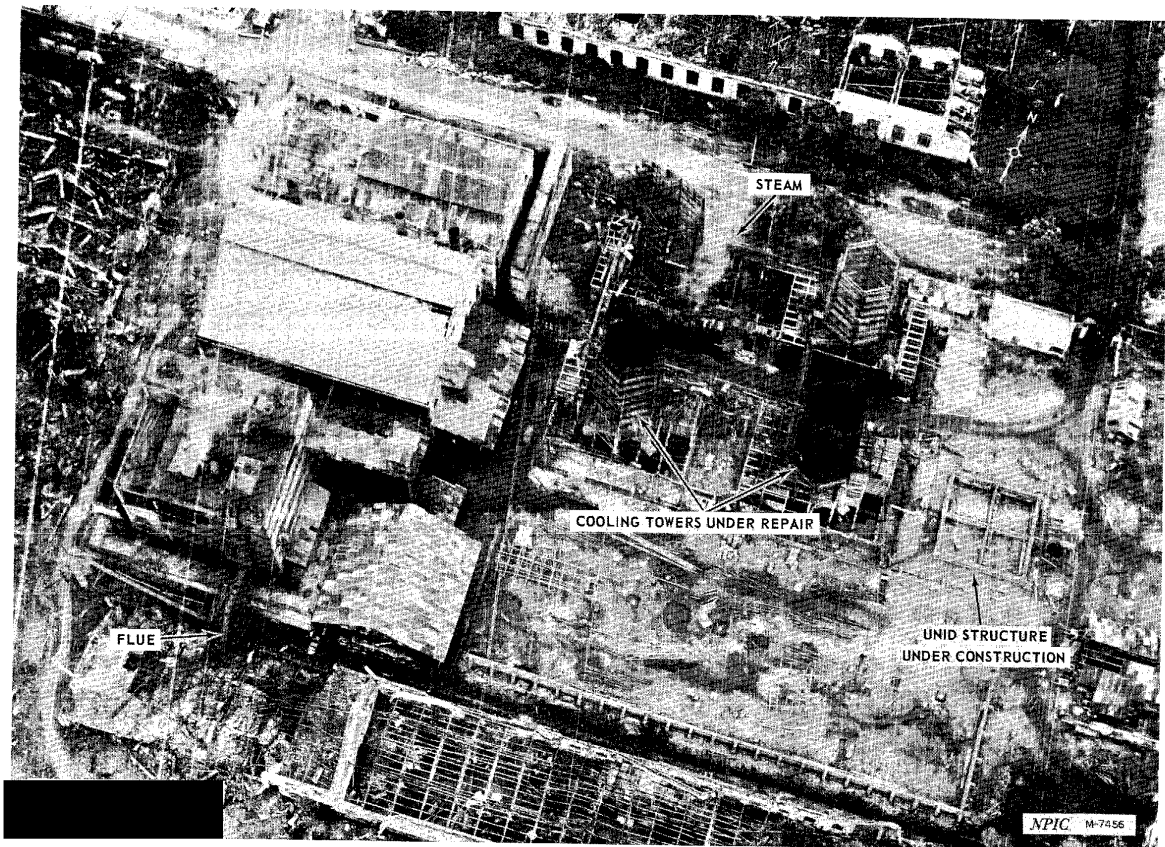
FIGURE 3. THERMAL-ELECTRIC POWERPLANT, NAM DINH, NORTH VIETNAM

The first evidence of major exterior repairs to any of the thermal-electric powerplants in North Vietnam has been observed at Nam Dinh. Previously, only minor repairs to the roofs and coal sheds have been observed. At the Nam Dinh TPP, two of the four heavily damaged cooling towers are being repaired (Figure 3). A new coal processing and storage building and an unidentified structure are also under construction. Apparently this plant has been operational since initial repairs were completed in [REDACTED].
